THE CALIFORNIA EARTHQUAKE OF APRIL 18, 1906

REPORT

STATE EARTHQUAKE INVESTIGATION COMMISSION

VOLUME I

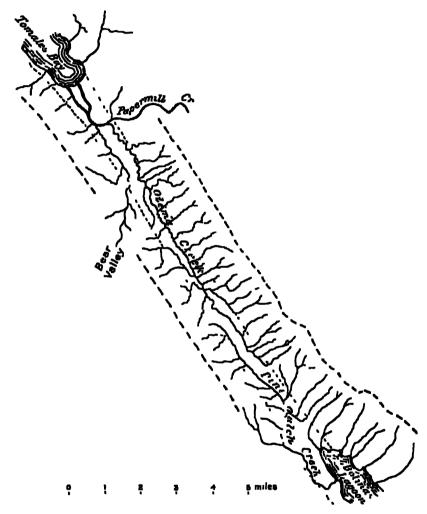
Fig. 2 — Dramage map of Bohnas-Tomales Valley. Heavy bloken lines show cleats of bounding ridges. Light broken lines indicate limits of Rift topography

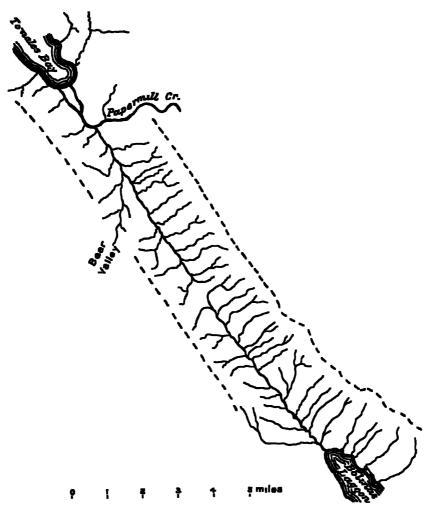
Fig. 3 — Hypothetic drainage map of Bolinas-Tomales Valley, if developed without influence of Rift displacement. Compare fig. 2.

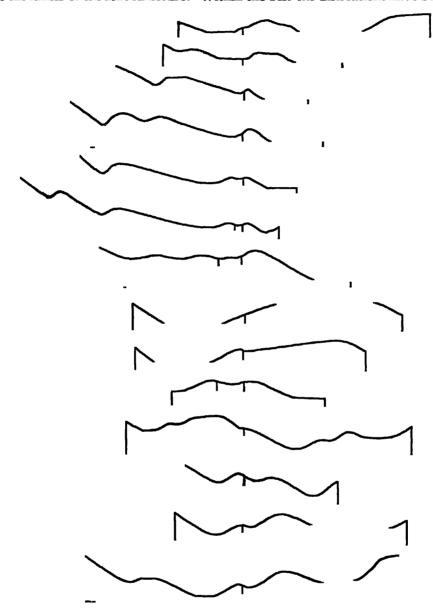
Fig. 9.—Cross-profiles of the Rift arranged in geographical order with the most northerly at top and northeast ends at the right. Positions of fault-trace and its branches are indicated. The profiles are copied from field sketches made without measurement.

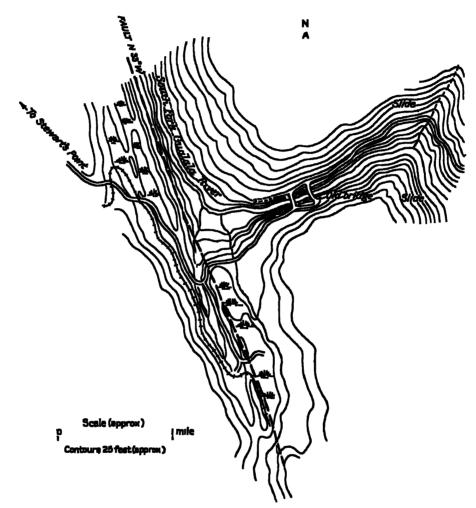
Fro 13 — Map of valley of South Fork of Gualaia River, showing relation of fault-trace to geomorphic features.

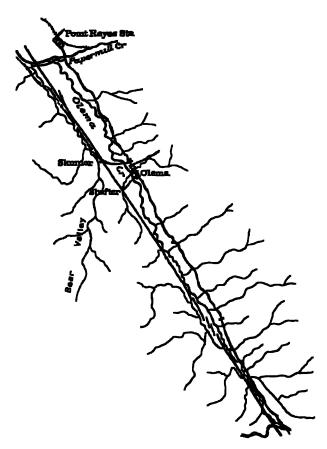
Fig 16 — Map of fault-trace from Papermill Creek southward Scale, 1 (2,500

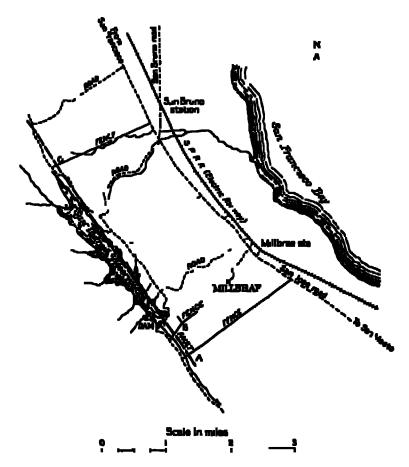
I'm 30 — Index map showing positions of three femore, A, B, and O, the offices of which are above in figs. 81, 37, and 35

The index map, fig 30 (p 05), indicates the position of three dislocated fences which were surveyed by R B Symington, CE. The fences are marked 1, B, C. One of those fences, C, near the upper end of San Andreas Lake, is nearly normal to the trace of the fault, and its deformation extends over a zone 1,200 feet wide, the total displacement aggregating 16 9 feet. Here, as usual, the portion on the southwest side of the fault moved relatively to the northwest, but there was a distinct diag on the northwest side in the same direction. (See fig 31)

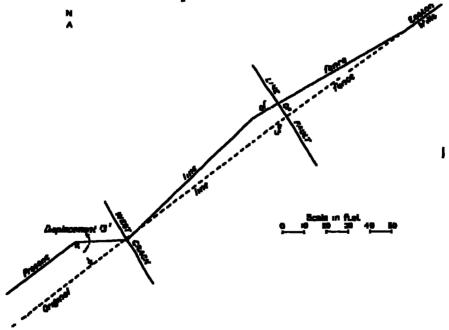
Fig. 13 — Dislogation of Janes near flan Andreas Lako - After II Hebustles

The offsets in three other tences southeast of San Andreas Lake are shown in figs 32, 33, and 31 and plates 60n and 61n

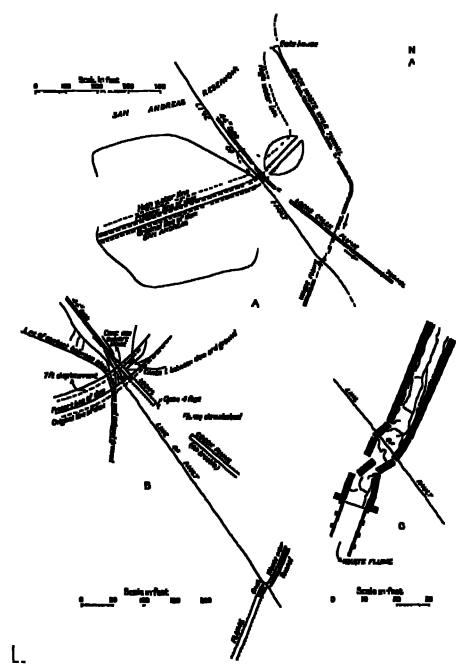
Fro M. Main and anytha y faults, San Andreas Luby 1 Georgial Plan B Detail After H Schumber

lake for the first 0 875 of a mile of its length. It then enters the water (plate 61b) and follows the northeast side of the lake, a little distance from shore, to the San Andreas dam at the lower end of the lake. In this distance of nearly 2 miles, the fault-trace emerges from the water at a number of points where little capes project into the lake. The crossing of these capes by the fault-trace indicates that it follows a very straight course beneath the water of the lake. On the last of these promontories traversed by the fault, the main fault-trace has associated with it a number of auxiliary cracks. Between the main fault-trace and one of the diverging cracks, on the southwest side of the fault, is a brick and cement gate-well in connection with the tunnel which takes the waters from the lake toward Millbrac. This gate-well was cricular in cross-section, the inside diameter being about 26 feet. The nearest point of the structure to the main fault-trace is within 5 feet.

The walls are about a foot thick, and are strongly buttiessed. As a result of the shock this gate-well was shattered and deformed so that it became oval in cross-section, the east and west diameter becoming 30 feet and the north and south diameter about 21 or 22 feet, as shown in the accompanying figure. A new concrete gate-well a few feet to the north, rectangular in cross-section and having three compartments, each 2.5×2.5 feet, was uninjured, altho on the line of the same branching crack. A concrete manhole 45 feet northeast of the damaged gate-well, also on an auxiliary crack, was similarly unaffected. (See fig. 35.)

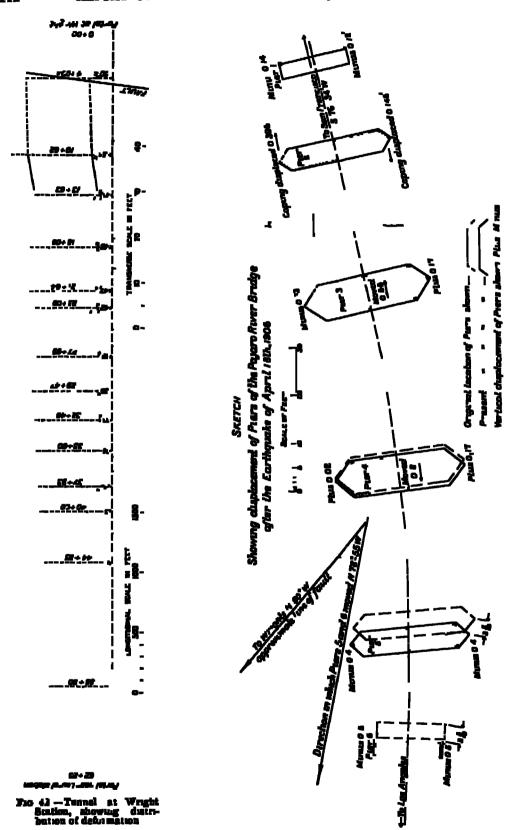
The length of the tunnel is 6,200 feet. Its direction is 5, 30 Ze o w a limit the tunnel 100 feet from the northeast portal, along which there was a lateral displacement of 4 5 feet. The movement on the southwest sule was northerly with reference to the northeast side. Nothing of this fissure can now be seen, as the tunnel along that part has been excavated, the walk timbered and entirely obscured from view. My description rests to the state. The length of the tunnel is 0,200 foot Its direction is 8. 48° 24' 5 W A firsture grost excavated, the walls timbered and entirely obscured from view. My description on my examination soon after the earthquake, before any work had been done of this firsure is N. 52° W, making an angle of 80° with the trend of the tunnel, and it dips at an angle of about 75° to the wort. The walls of the fissure were well smoothed and slicken-sided, but I did not determine the direction of the street Specimens from this fraure indicate that the fault occurred in sandstone, and that much movement had already taken place along the same fault in apparently a variety of directions — Specimens secured at the time have changed from a dainp, sticky, elay-like mass to a relatively dry, hard, and crumbled condition bitcake of light-colored sandstone occurred in this dark attrition material

The damage to the tunnel itself consisted in the caving in of everload took, the crushing in toward the center of the tunnel of the lateral upright timbers, and the heaving upward of the tails, due to the upward draplacement of the underlying ties. In some instances these ties were broken in the middle. In general the top of the tunnel was carried north or northeast with reference to the bottom. This seems to be the prevailing condition in the

I examined with particular care the walls of the tunnel at several points where the damage to the timbers appeared to be greatest, more especially between 1,400 feet and 2,200 feet in from the opening at Wright. At each place I found several fissure lines running somewhat irregularly, but in general parallel to the fissure already described 400 feet in from the entrance at Wright. These fissures all contained more or loss attrition material Three of them I had an opportunity to examine better than the others. In each case two distinct sets of stree were found, one set vertical and the other set housental. The hornsontal set was clearly more recent than the vertical set, and to all appearances might have been formed the day before. The three sheken-sided faults mentioned were the only ones that lookt as if recent movement had occurred. The rocks in the tunnel look like sandstones and jaspers of Franciscan age According to the ovidence, so far as it went, the whole of the top of the mountain is fissued through in such a way that a large movement could be distributed among several fissures and thus account for a relatively slight motion along any one fissure. The measuring of any minor movements in the tunnel would be difficult because of the caving in of the rocks at such points. It would seem, too, that such movement could occur without materially altering the line of the tunnel at that point, so far as the tumbering is concerned.

Engineers' measurements of displacement — The reconstruction of the tunnel at Wright Station necessitated an instrumental survey of the displacement in so far as it immediately affected the structure. The results of this survey have been placed at the disposal of the Commission by Mr J D Matthews, assistant resident engineer in charge of the work The plot of the survey is given in fig 42. The plot shows that, while the tunnel is travorsed by only one fault fracture, at a distance of about 400 feet from the northeast portal the deformation has been distributed over a distance of nearly a mile. This deformation of the tunnel, or its departure from a straight line, is measured from a line drawn from the northeast portal to a point on the same side of the tunnel 075 feet in from the southwest portal It indicates a bonding of the ground to the northwest in the direction of the relative displacement on the southwest side of the fault. That is to say, the bending is in the opposite direction to that which would be characteristic of the diag of a fault A possible explanation of this phonomenon is that the ground pieceed by the tunnel was in a state of excessive closuc stress, even at the time the tunnel was constructed, and that the relief effected by the rupture rendered residence operative and so caused the ground to be fleved in the sense opposite to that of a drag The nature of the deformation of the ground on the northeast side of the fault is not yet known. It may be here mentioned in regard to the effect of the fault upon the steel budge at Chittendon, that, in addition to the cracking and displacement of the supporting pions, as noted by Mi Waying, the distance lectween the abutments was lengthened about 3.5 foot, according to measurements supplied to the Commission by Mr. J. II. Wallace, Assistant Chief Engineer, Southern Pacific Company and illustrated in the accompanying diagram, fig 13

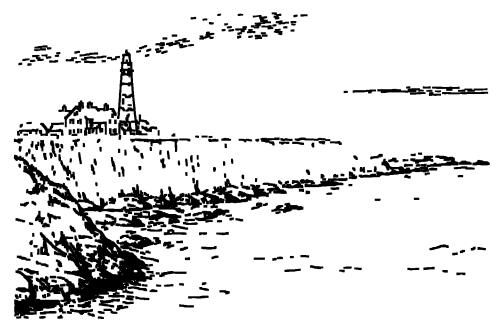
Lus 19 - Can ke in light house tower, Point Arens

Point Alena light-house, elected 1870, a brick tower 110 feet high on a high, rocky point, is still standing but dismantled and condemned. It was broken clear thru in sections, as shown in fig 49. It icans slightly to the north. The keeper on watch in the tower says

"A heavy blow flist struck the tower trong the south. The blow came quick and heavy, accompanied by a heavy report. The tower quivered for a few seconds, went far over to the north, came back, and then swung north again, repeating this several times Immedi-

the north, came back, and then swing north again, repeating this several times—immediately after came rapid and violent vibrations, rending the tower apart, the sections grinding and grating upon each other, while the lenses, reflectors, etc., in the lantern were shaken from their settings and fell in a shower upon the mon floor."

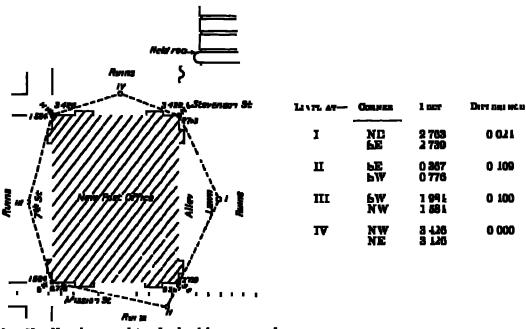
Fig. 52 -- Map showing relative levels of four council of new Post-office, but Francisco

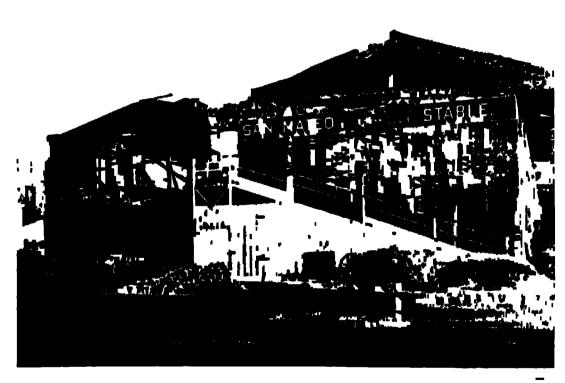
A. Wreck of 1-story ledek reflects werehouse, then Marine. Per J. G. R.

2. Brick stable, for Matte. Types stary was thereon and and decade on stary. Part. C. B.

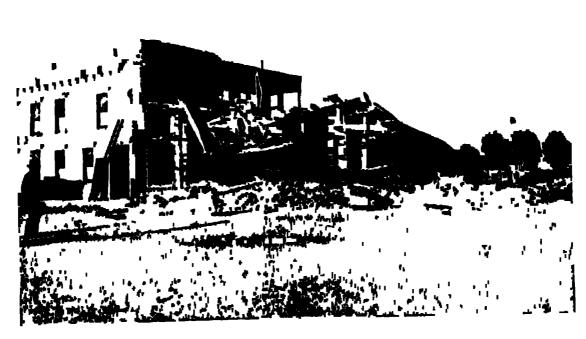
A. Wronk of I stary brick building, San Majoo Per J. G. R.

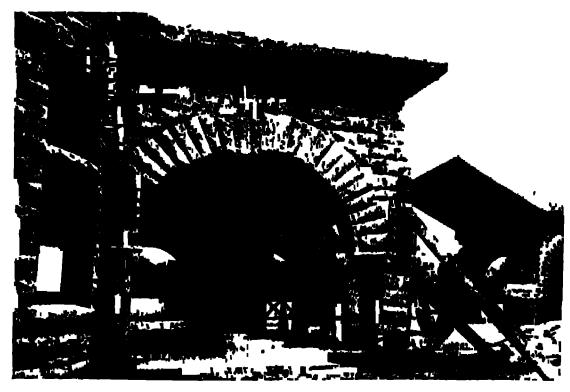
A Note of Managial Arab, Stanford University. Per J. C. R.

3 Front View of Managelel Clerch, Mandard University.

A. Wresk of Library Building, Stanford University Per J. C. B

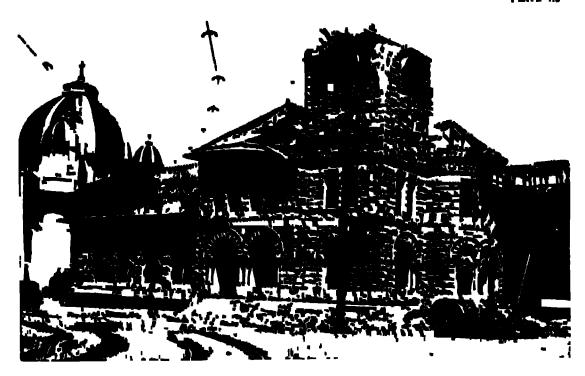
A. Pest-effet, Sex Jens.

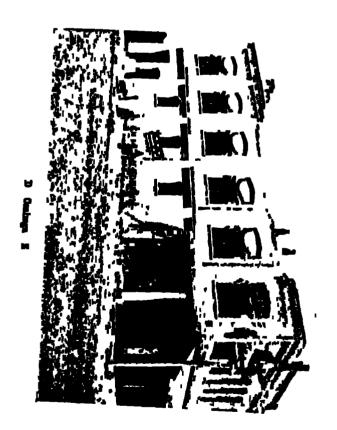
Les Banos — On emerging from mountainous districts into the deep alluvial plains of the San Joaquin Valley, the intensity of the shock increased, until at Los Banos it reached a maximum. A count of the chimneys showed 57 per cont (17 out of 30) fallen All the brick chimneys were damaged, as shown by the accompanying photographs (Plate 123a, c.). A poculiar feature of the effect upon these structures was that all the damage was on the northeast and southwest sides. Frame buildings were not damaged beyond the falling of plaster, or the throwing down of chimneys. According to the statements of the residents, and the data obtainable, the vibratious were north and south

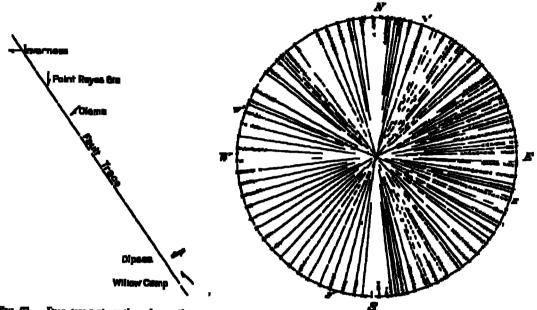
At Dipre Inn, 0 66 mile northeast of the fault, a pior running northeast from the spit was weaked toward its outer end. A line of telephone pokes encoung the lagoon from the end of the pier was stanted in the same northeast direction. In the Inn objects were thrown southwest, and of three cottages injured two was shifted or wracked to the southwest. On the mainland nearby a part of Mr. Morse's pier was wracked to the southwest. Collectively these facts indicate a dominant vibration to and from a northeast direction.

At Willow Camp, close to the east angle of Bolinas Lagoon and about a mile northeast of the fault, several houses moved short distances toward the southeast

These various directions are platted in fig 65.
